PORT PERRY DAM  
PERRY COUNTY, MISSOURI

MISSOURI INVENTORY NO. 30030

PHASE I INSPECTION REPORT  
NATIONAL DAM SAFETY PROGRAM

PREPARED BY  
Kenneth Balk & Associates, Inc.  
St. Louis, Missouri  
Shannon & Wilson, Inc.  
St. Louis, Missouri

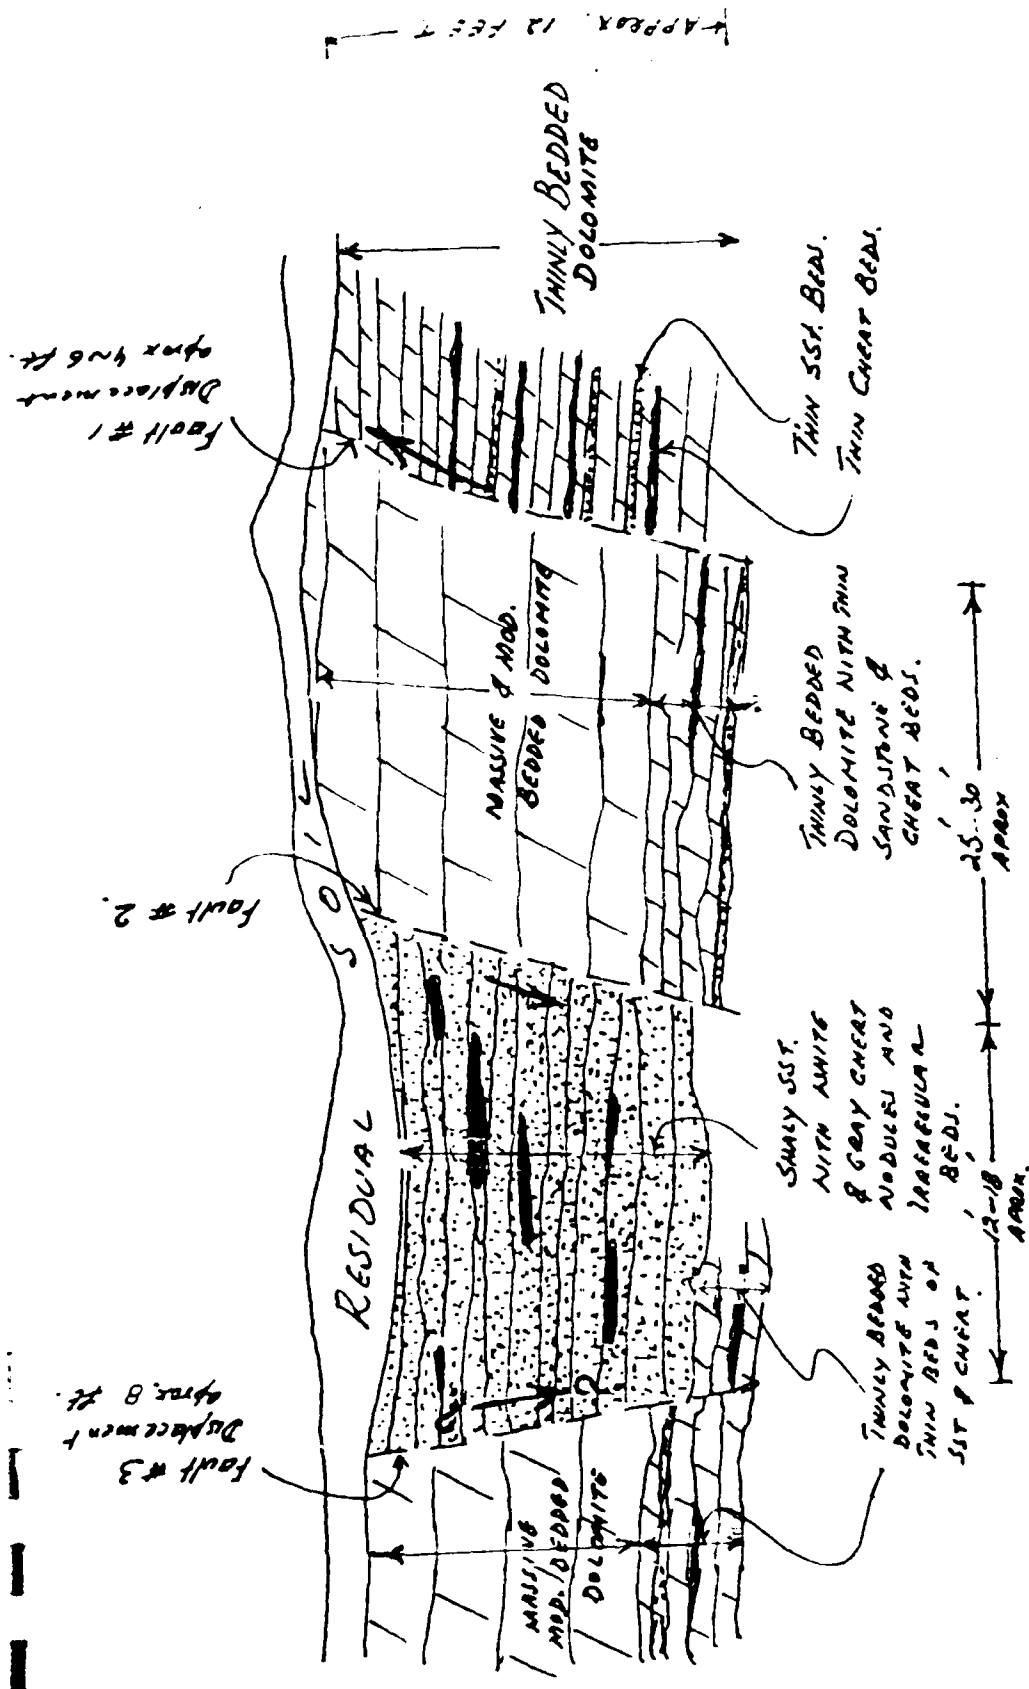
SKETCH SHOWING  
LOCATION OF FAULTS.  
(NOT TO SCALE)  
VERTICAL SCALE ENLARGED  
PLATE 5

1) Right Abutment - The right abutment is structurally disturbed. Three (3) normal faults were observed and with their approximate displacement are shown on Plate 5. Relative displacements are also shown. Dip and strike of the faults as observed are:

The existing faults in the right abutment are considered to be, in our opinion, a deficiency and the effect of the faults on the dam's stability should be assessed in detail by a professional engineer, experienced in the design of dams.
